ON-SITE HAZARD ASSESSMENT AND SAFETY INSPECTION

Property Name: Wheeler Recreation Areas	Property Address: Wheeler
---	-------------------------------------

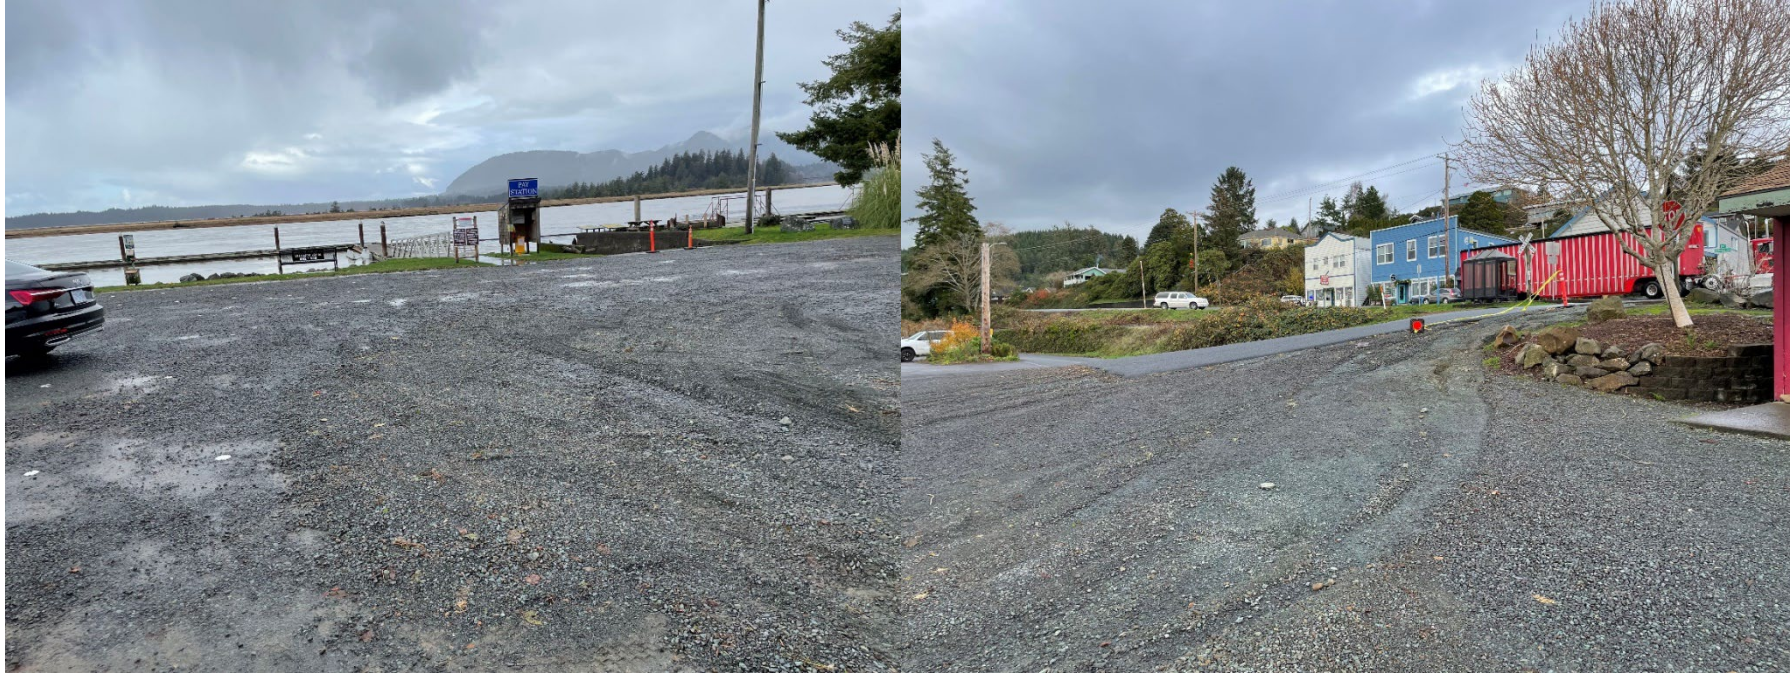
In the days prior to this inspection heavy rainfall caused flooding and damage to parts of the city and to this park. There was heavy waterflow through the park and the gravel foot path has deep ruts and holes and there are areas of mud build up and erosion. This has created uneven paths and slipping and tripping hazards. It seems an easy answer would be to level the gravel

Driveway to gravel paved lot at Waterfront Park. This area is used for people to walk between the town, park and dock. Recent heavy rains caused flooding and damage to the driveway and pathway into the park.

Another option would be for the city to invest in having the driveway and path graded and filled and daily monitoring and repairs as needed. Specific repair suggestions: bring in gravel to the level of the concrete bathroom foundation, fill in noticeable holes and level the path in the areas of deep rutting and any areas that can't be reasonably improved, mark closed and not authorized for access.

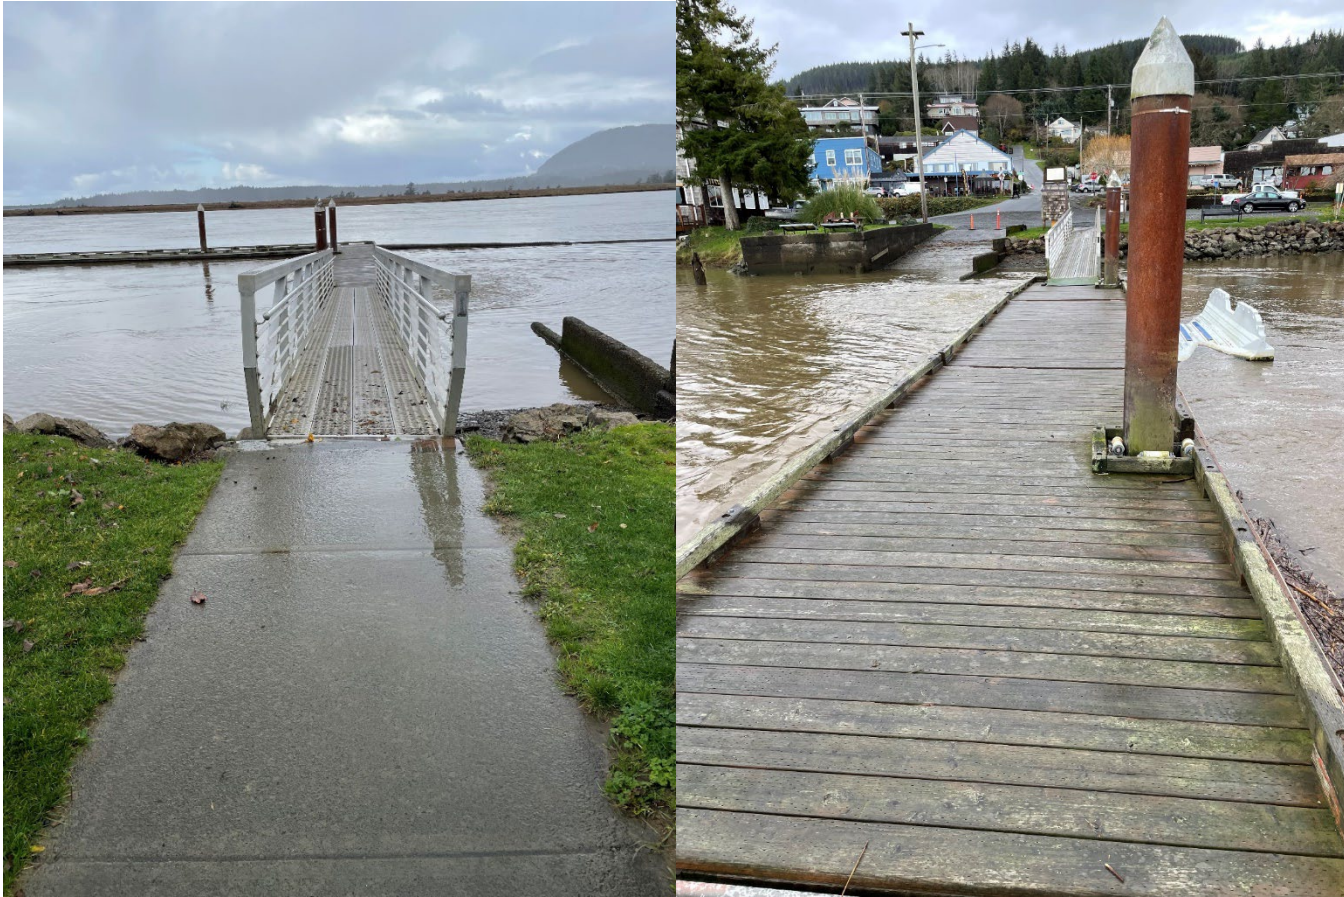
The paved driveway for Waterfront Park leads to a metal gangway and a dock over the Nehalem River. In recent days when the area flooded, water at the dock area is also very high and over the top of portions of the dock. There's a kayak lifter on the gangway that was not installed by the city and there is no known scheduled maintenance of the lifter. It's recommended that the city schedule dock cleaning to remove moss and any build up that can cause it to be slippery. If the city is not maintaining the kayak lifter, consider having it removed if it's not safe or putting up a sign that says it's not maintained and if used should be with caution and at the users risk.

Gangway to dock, kayak lifter on the side of the dock. The gangway is metal grating and leads to a wood dock. The wood is wet, slippery and showing signs of wear.

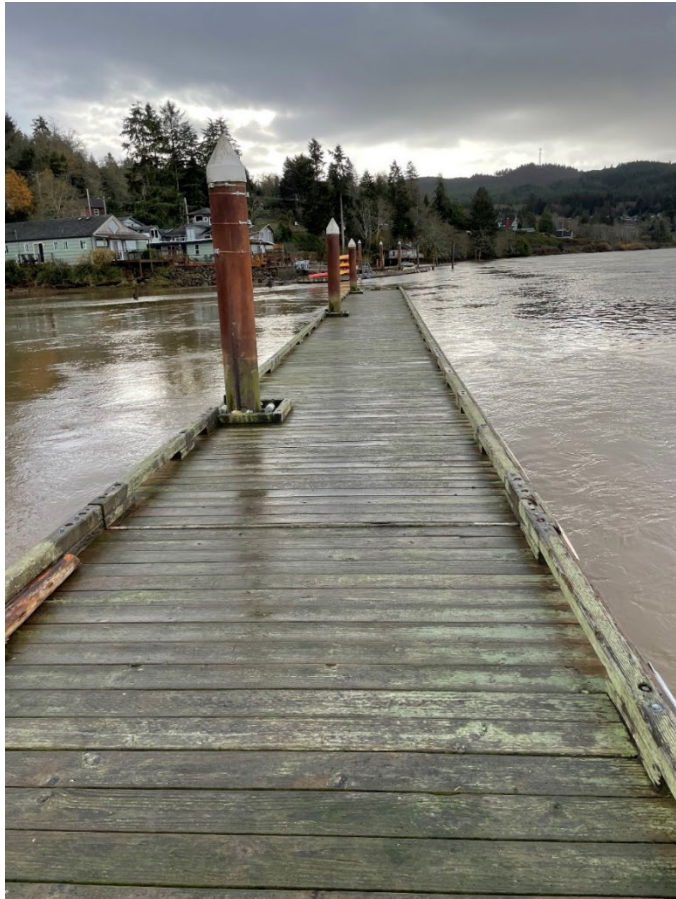
Dock- wet, slippery wood.

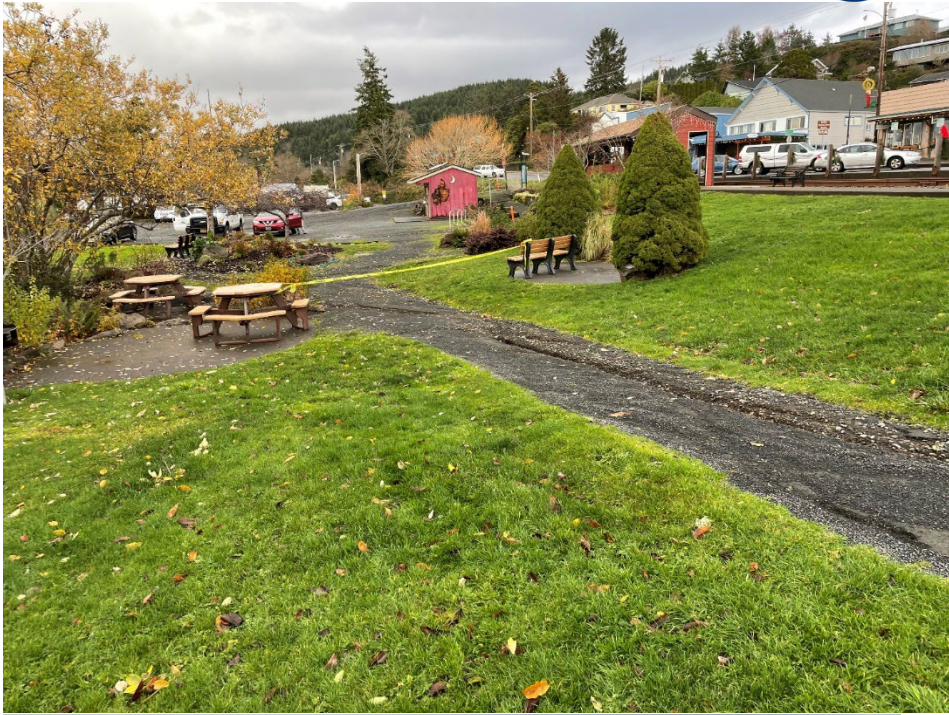
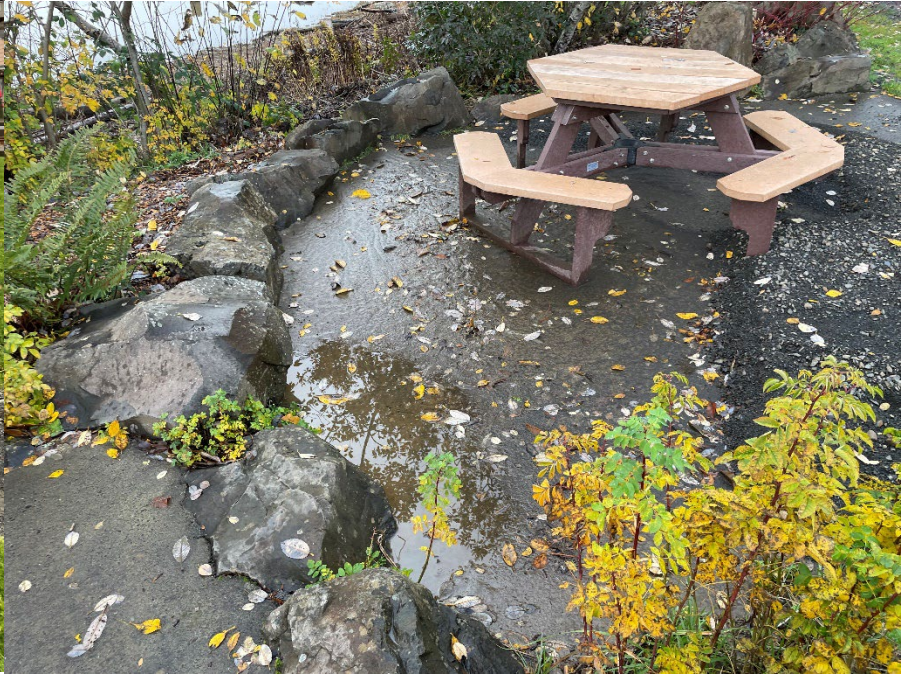
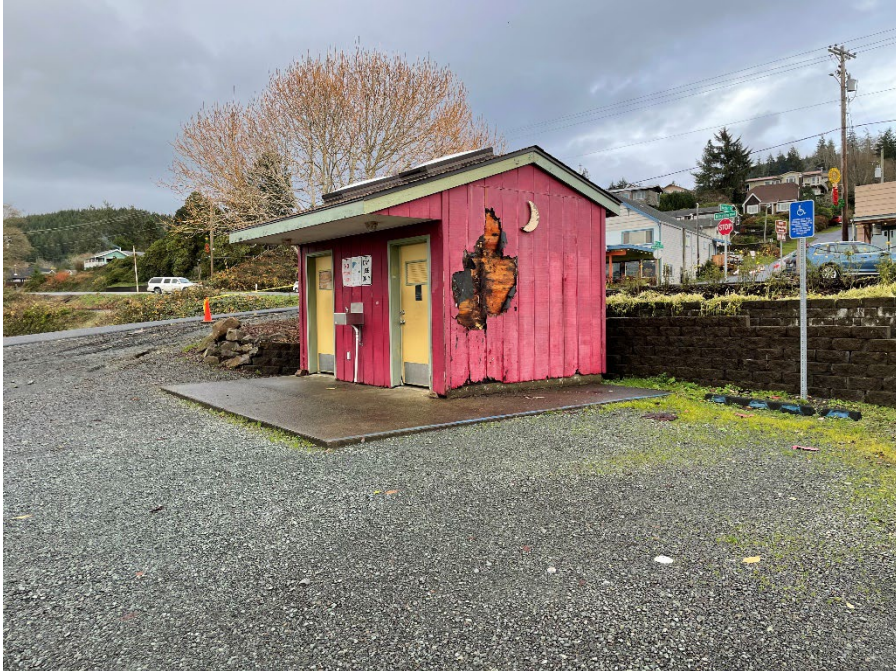
Waterfront Park- path was recently washed out, thick and wet mud is near the picnic table, holes and uneven path.

and fill holes and tripping hazards however, there is nothing holding the gravel in place and during these rainy months, a short-term fix would not last long. Because there are uses for this path other than to recreate and there is not a short-term reasonable cost to repair the pathways through the park, for that reason the best answer might be to put up signs that say the city does not authorize use of this park including the dock.

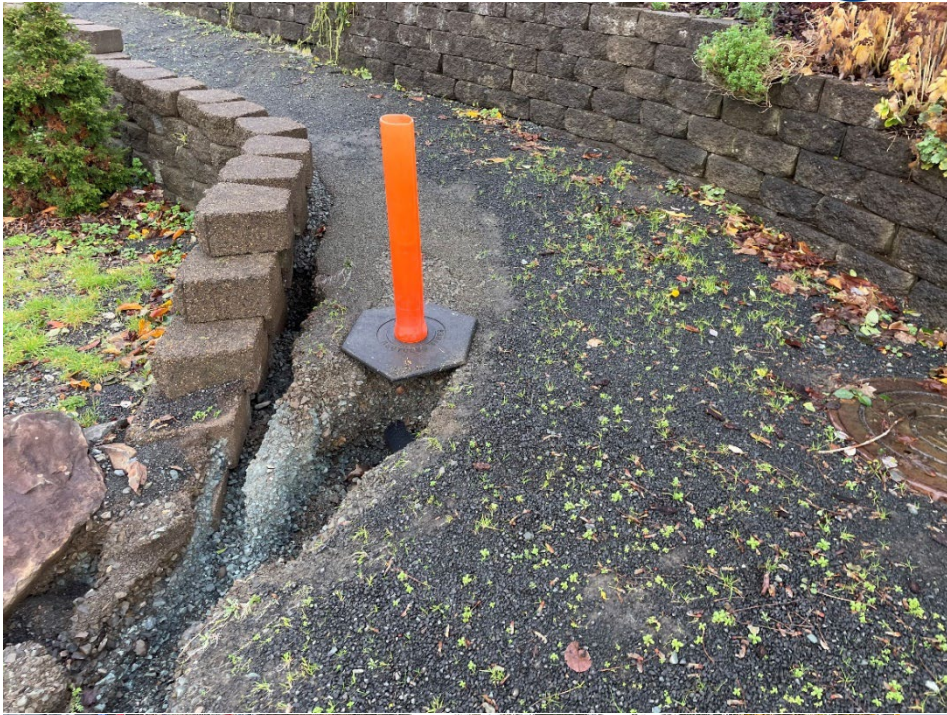
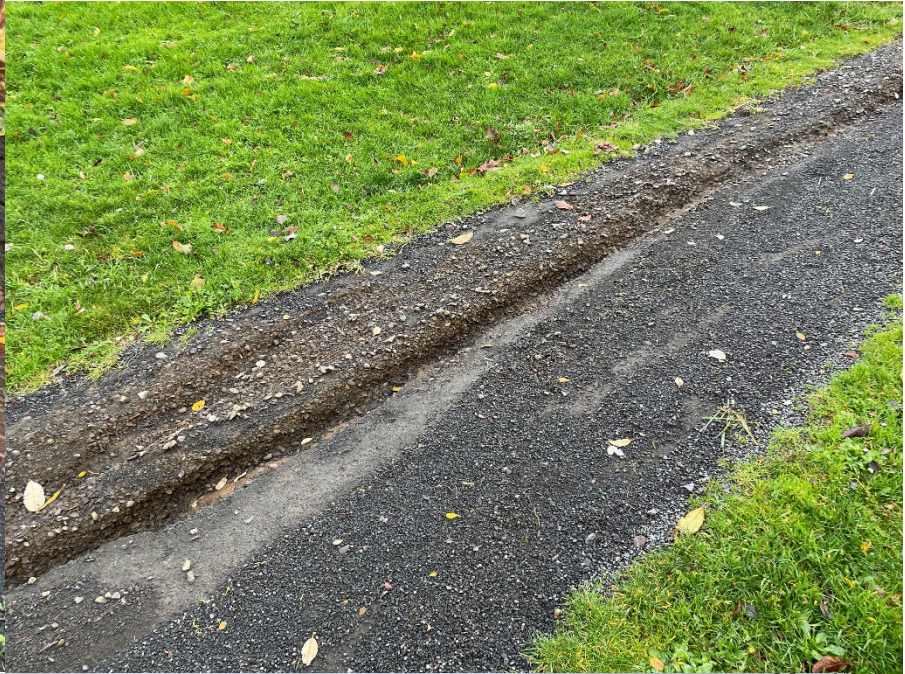
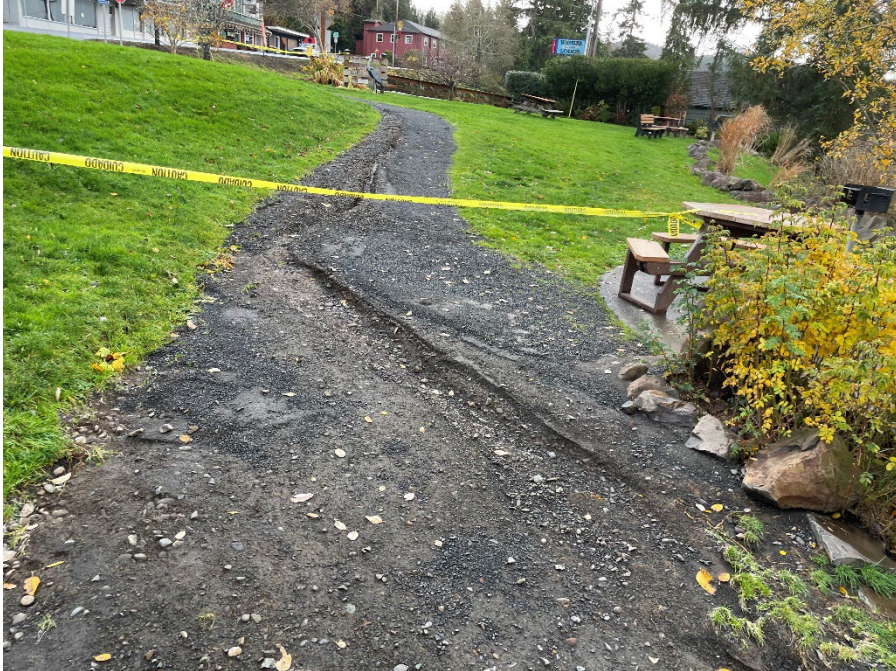
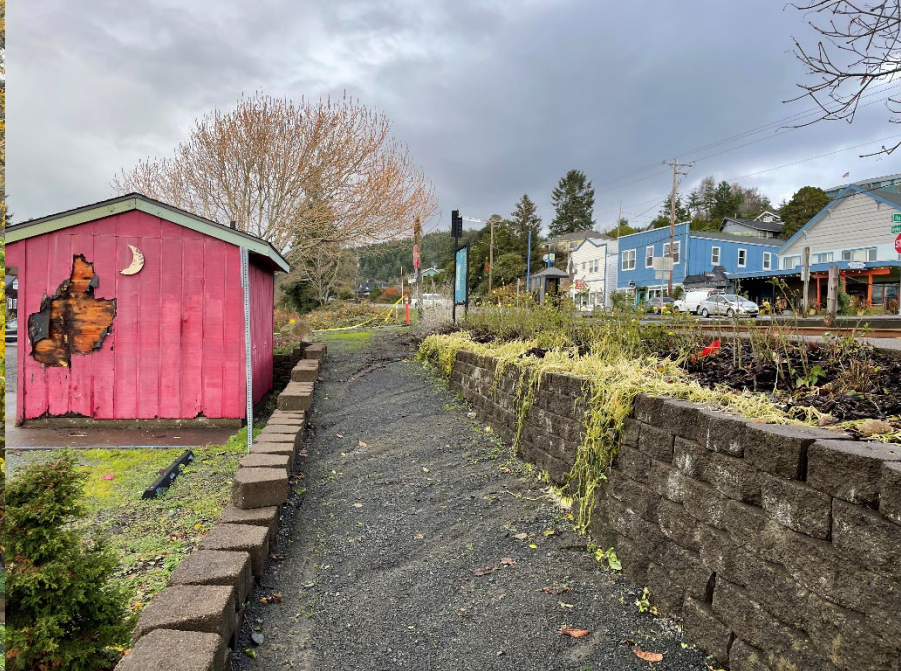
Waterfront Park- Path has divots, holes, and tripping hazards.

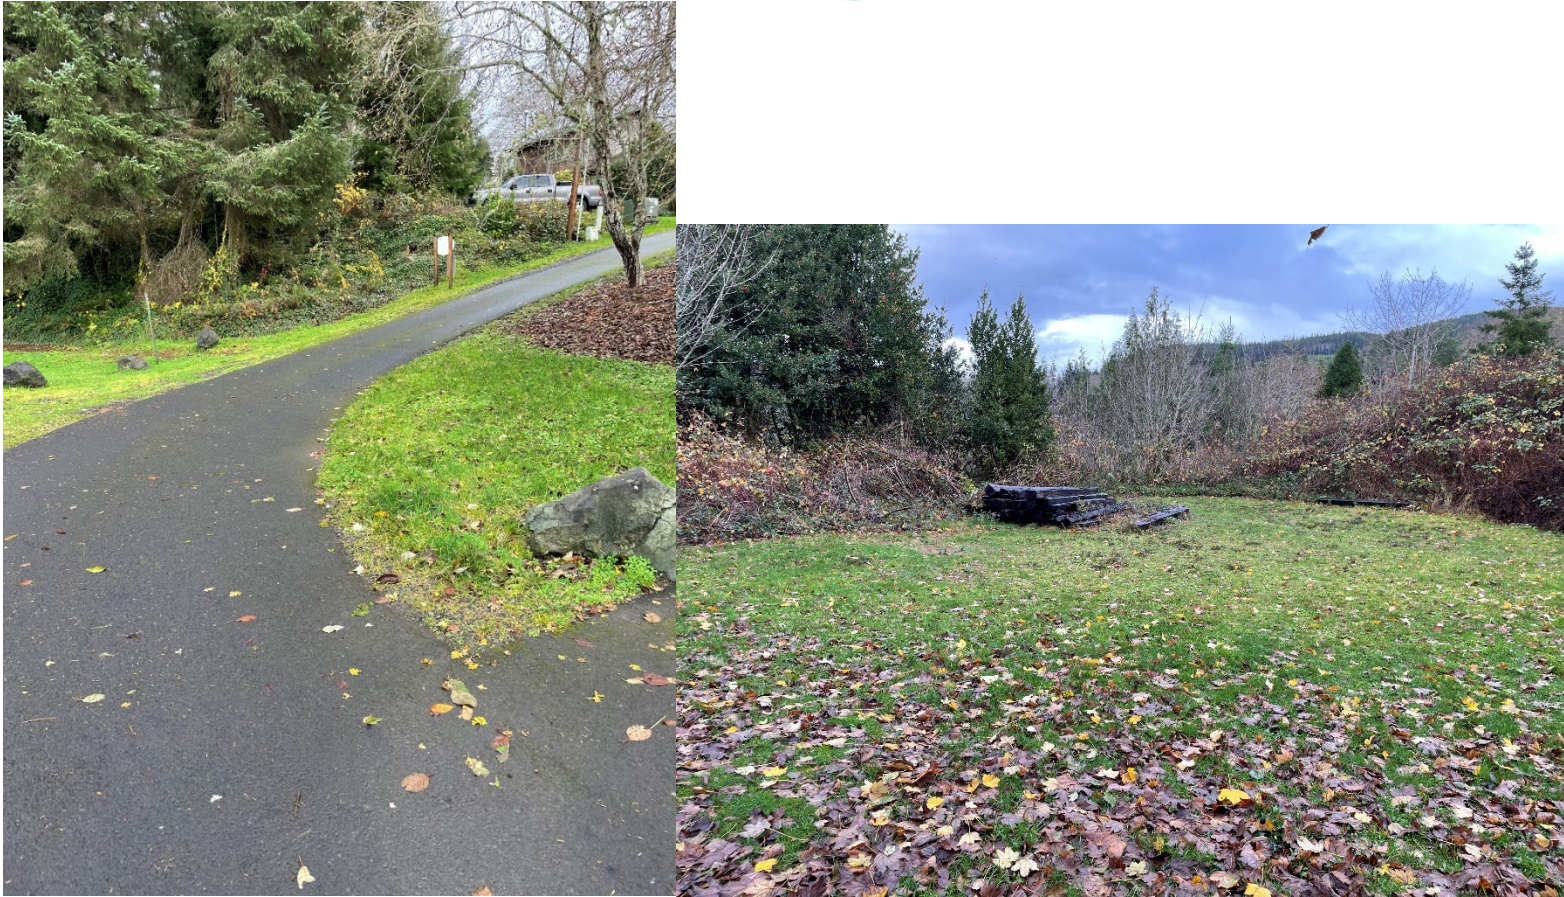
Upper Park – Driveway into parking lot, paved and well maintained. Park area w/railroad ties.

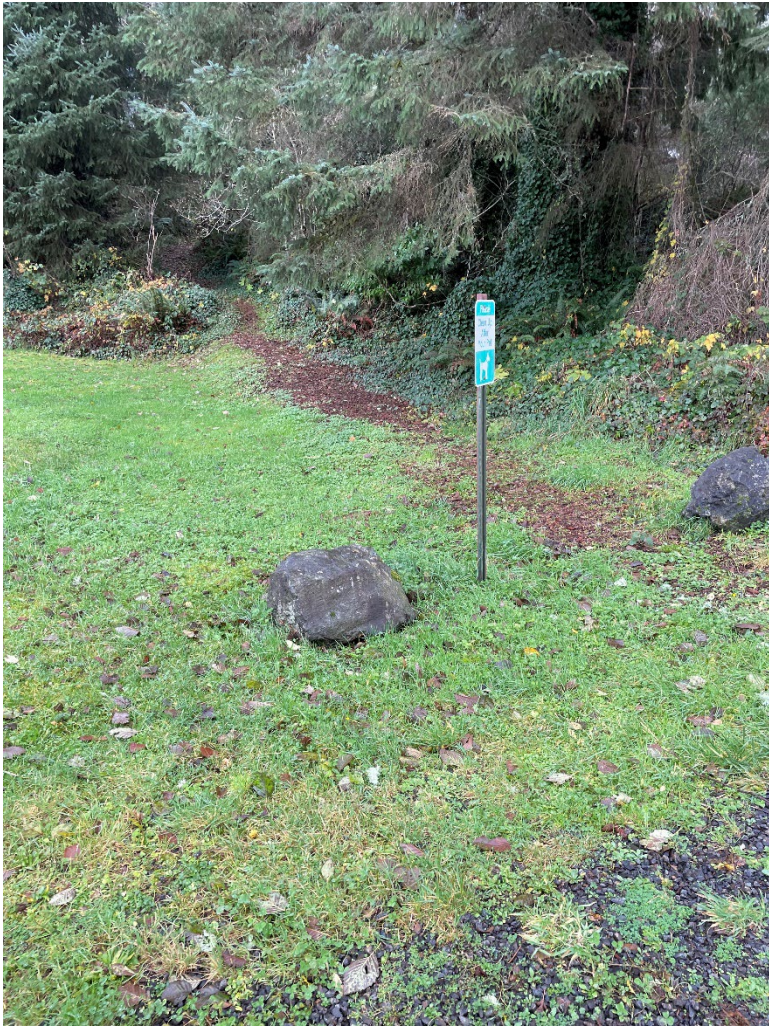
Man-made pathway into a development.

There is a man-made path near the parking lot that leads to the adjacent residential area. This path was not created by the city and is not maintained by the city. There is a small green sign that asks for dog owners to clean up after their pet. I suggested the city put up a sign that says this path is not city maintained and users should use it with caution and at their own risk.

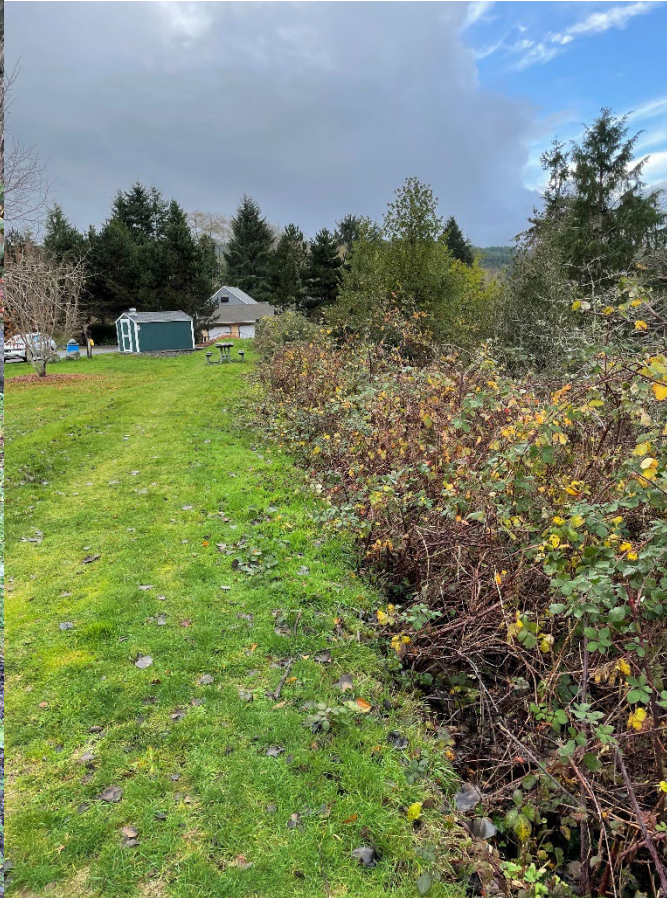
Bushes near a sloping area blocking the drop off in this area.

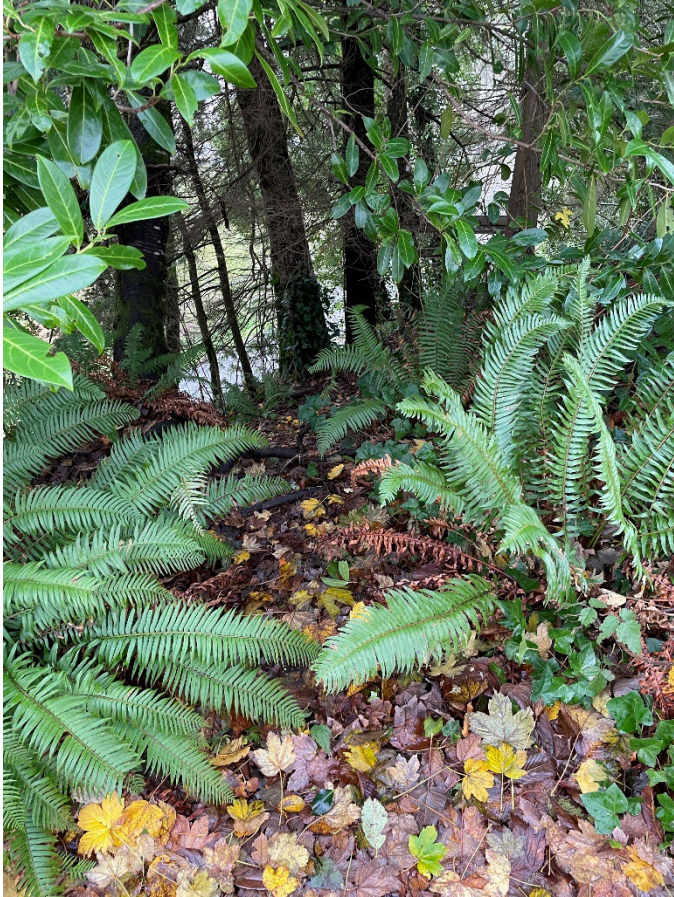
There is a second path on the northwest side of the path (see photos below) that's man-made, primitive and steep. I suggested the city put up a sign that says this path is not city maintained, it's steep and use is with caution and at their own risk.

Very primitive man-made trail- advise the city to sign this to alert users it is not maintained, steep and use is at their own risk.
